## What can I do to remove split peaks?

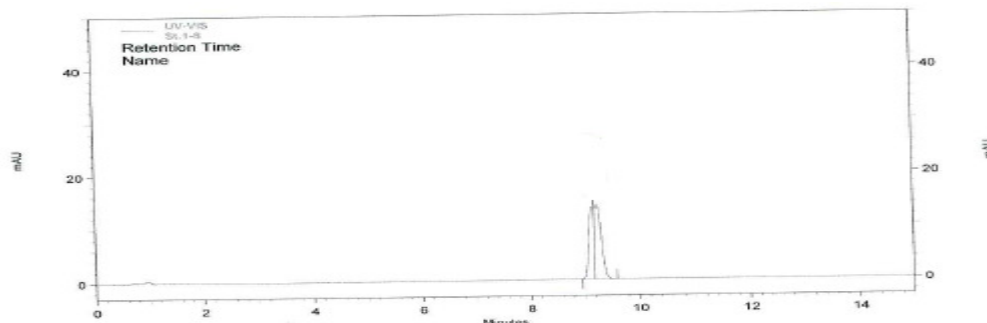
Example:

1. pH of the mobile phase is close to the pKa of a functional group on the compound and/or not buffered adequately.
2. a physical blockage obstructing the flow path
3. a void or channel in the column

1. Adjust the mobile phase pH +/- 2 units above or below the pKa of the compound's ionizable functional group, and buffer at that pH with an appropriate buffer (of sufficient buffer capacity to ensure the pH is controlled to the desired pH).
2. Preventative measures such as filtering the samples prior to injection and/or using a guard cartridge to protect the column are the best steps to take.
3. Discard column and replace with a new one (a void or channel in the column packing bed cannot be repaired or regenerated). If this occurred prematurely (expected column lifetime very application specific), consider the mobile phase components, backpressures, and sample to confirm if the running conditions are within the tolerances of the particular column.

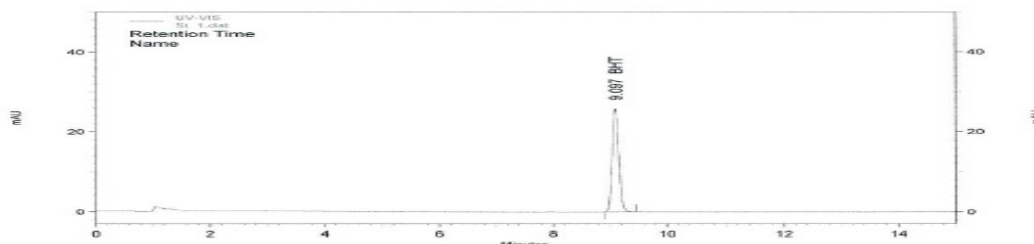
In this case, the compound was butylated hydroxytoluene, with no ionizable functional groups. Column washes did not yield any improvements, however, reverse flushing the column quickly restored the peak shape (chromatogram below). This reversing of the column was therefore sufficient to remove the blockage on the column inlet that was obstructing the flow path (recommended to remove from detector to waste when reverse flushing to avoid contaminating the detector).
